RECOVERY OF BURIED
INDUSTRIAL WASTES
AND
AQUIFER REHABILITATION
AND
MONITORING AT OLIPHANT,
BRUCE COUNTY

RECOVERY OF BURIED INDUSTRIAL
WASTES AND
AQUIFER REHABILITATION AND
MONITORING AT OLIPHANT,
BRUCE COUNTY

Prepared
by
B. Novakovic

Southwestern Region
Technical Support Section
Water Resources Assessment Unit
London
March, 1984

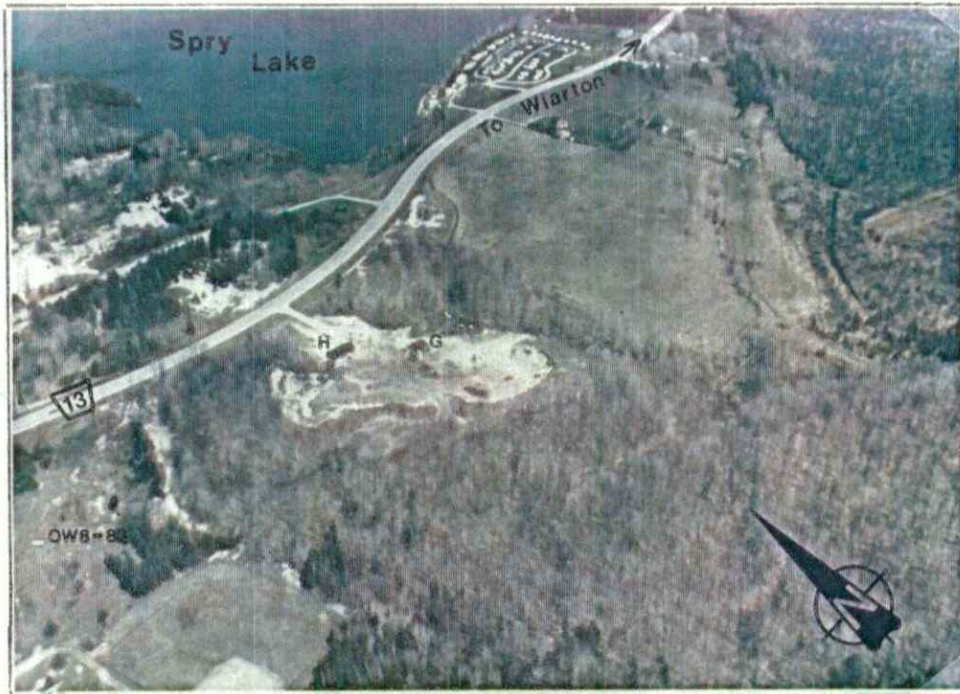
Photo 1. Aerial view of the Frank Field sand pit (centre of the photo) and the surrounding area.
(Photo taken on May 5, 1983 by Ron Johnson)

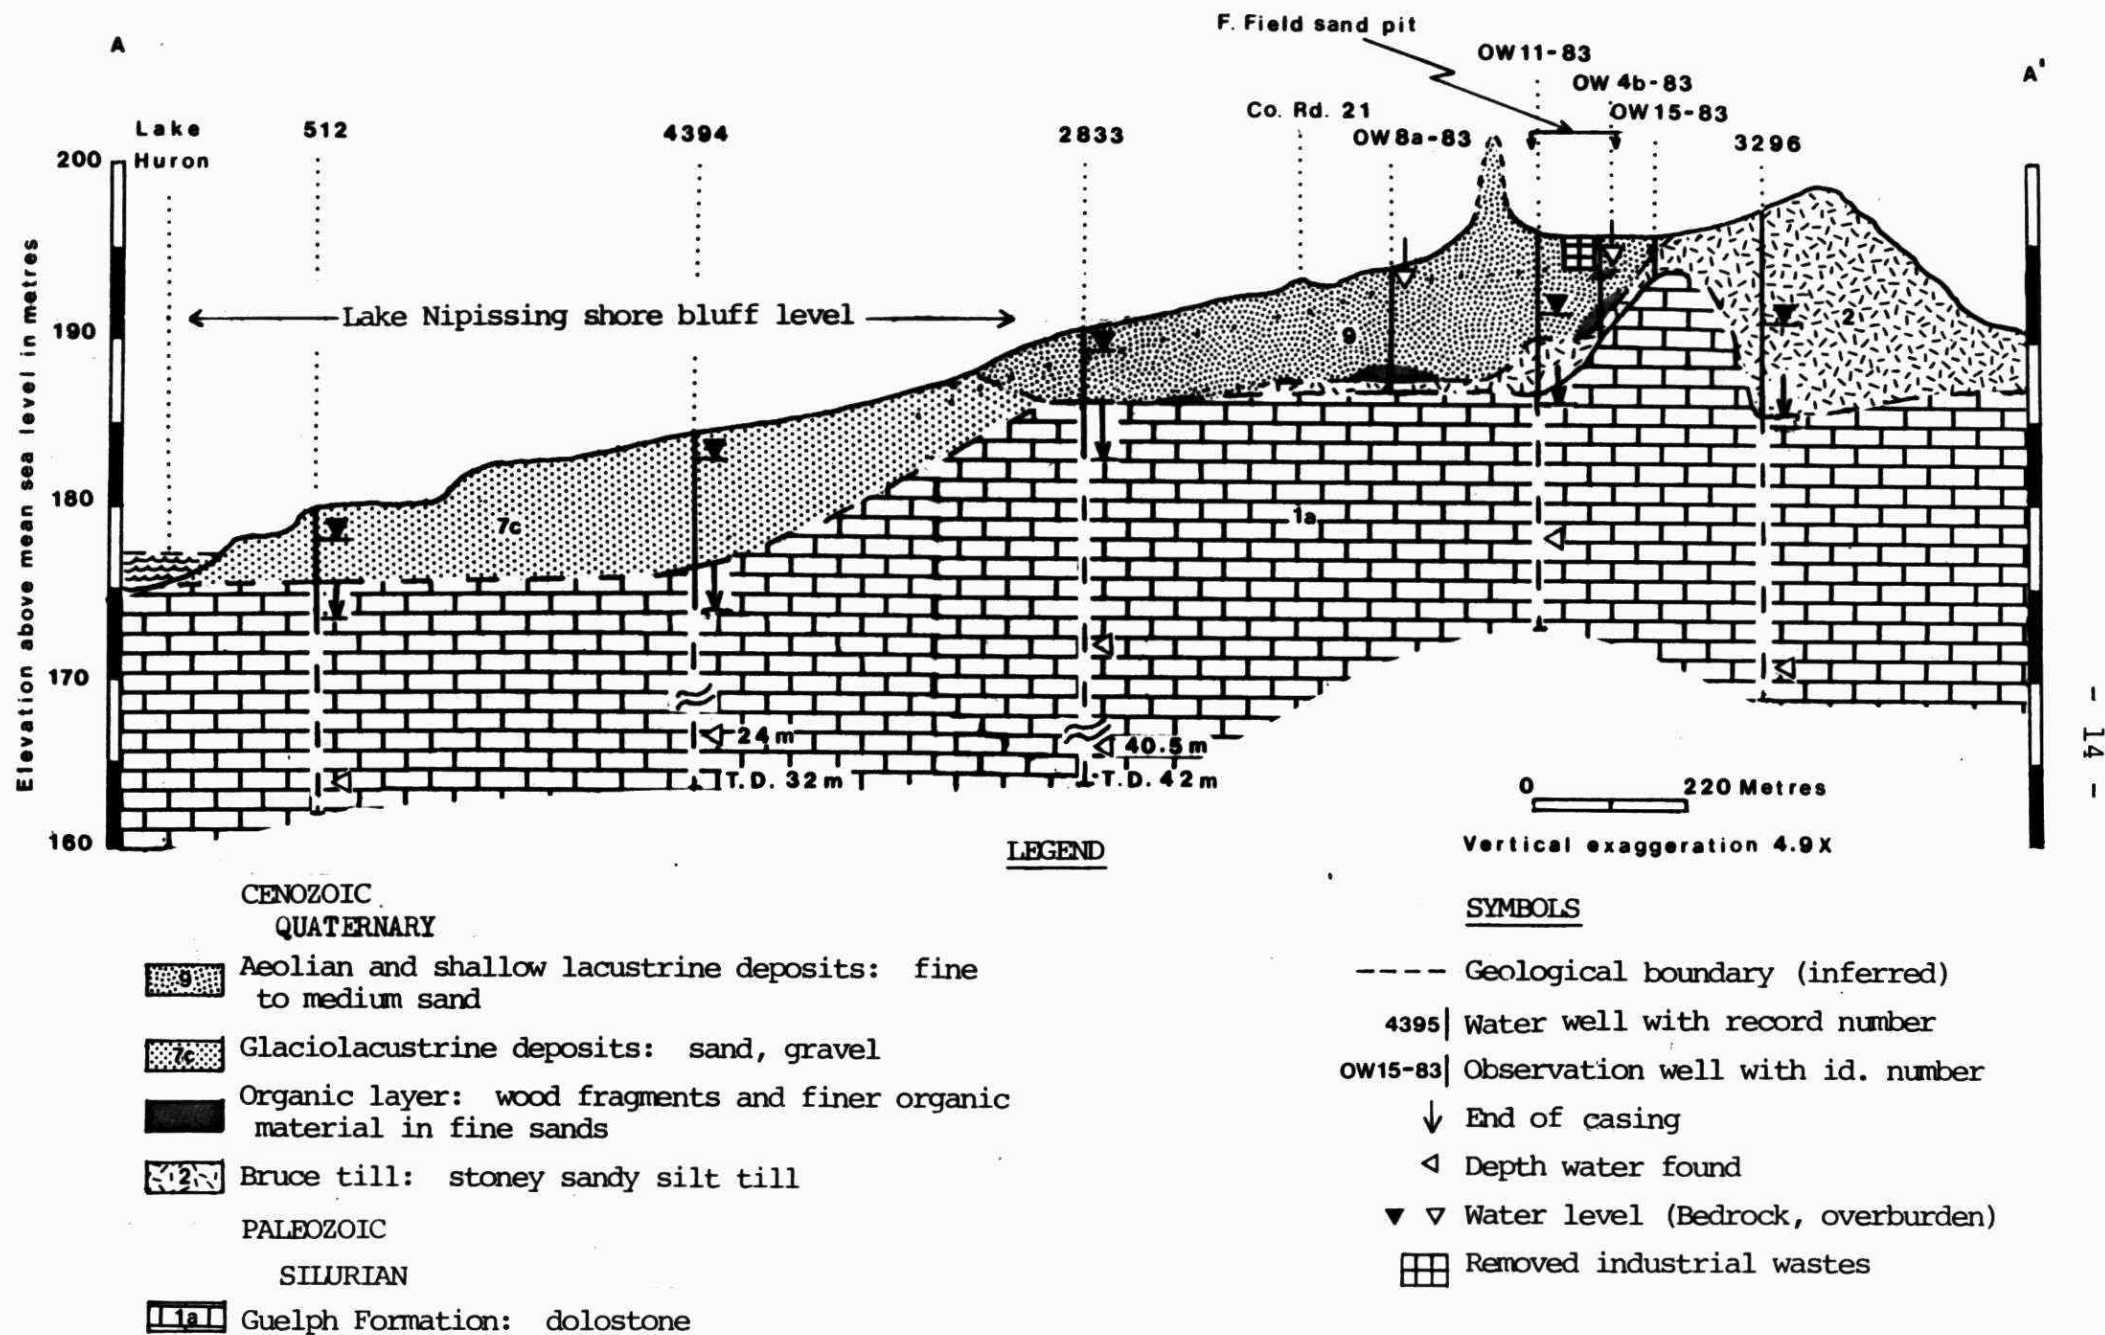
Figure 4. Cross-section A-A' illustrating regional geology and hydrogeology.

Based on the information from water well records and from the boreholes, the thickness of the unconsolidated sediments in the general area varies between 1.4 m and 12 m (Figures 3 and 4). As illustrated in Figure 4, in general the bedrock surface topography slopes in the westerly direction towards Lake Huron. An exception to this is immediately east of the Field property where it appears that there is a bedrock topography with only 1.4 m of overburden.

According to the information from water well records, groundwater flow in the bedrock aquifer is in the westerly direction with Lake Huron being the discharge area (Figure 4). Several bedrock water wells along the Lake Huron shore were reported flowing at the time of

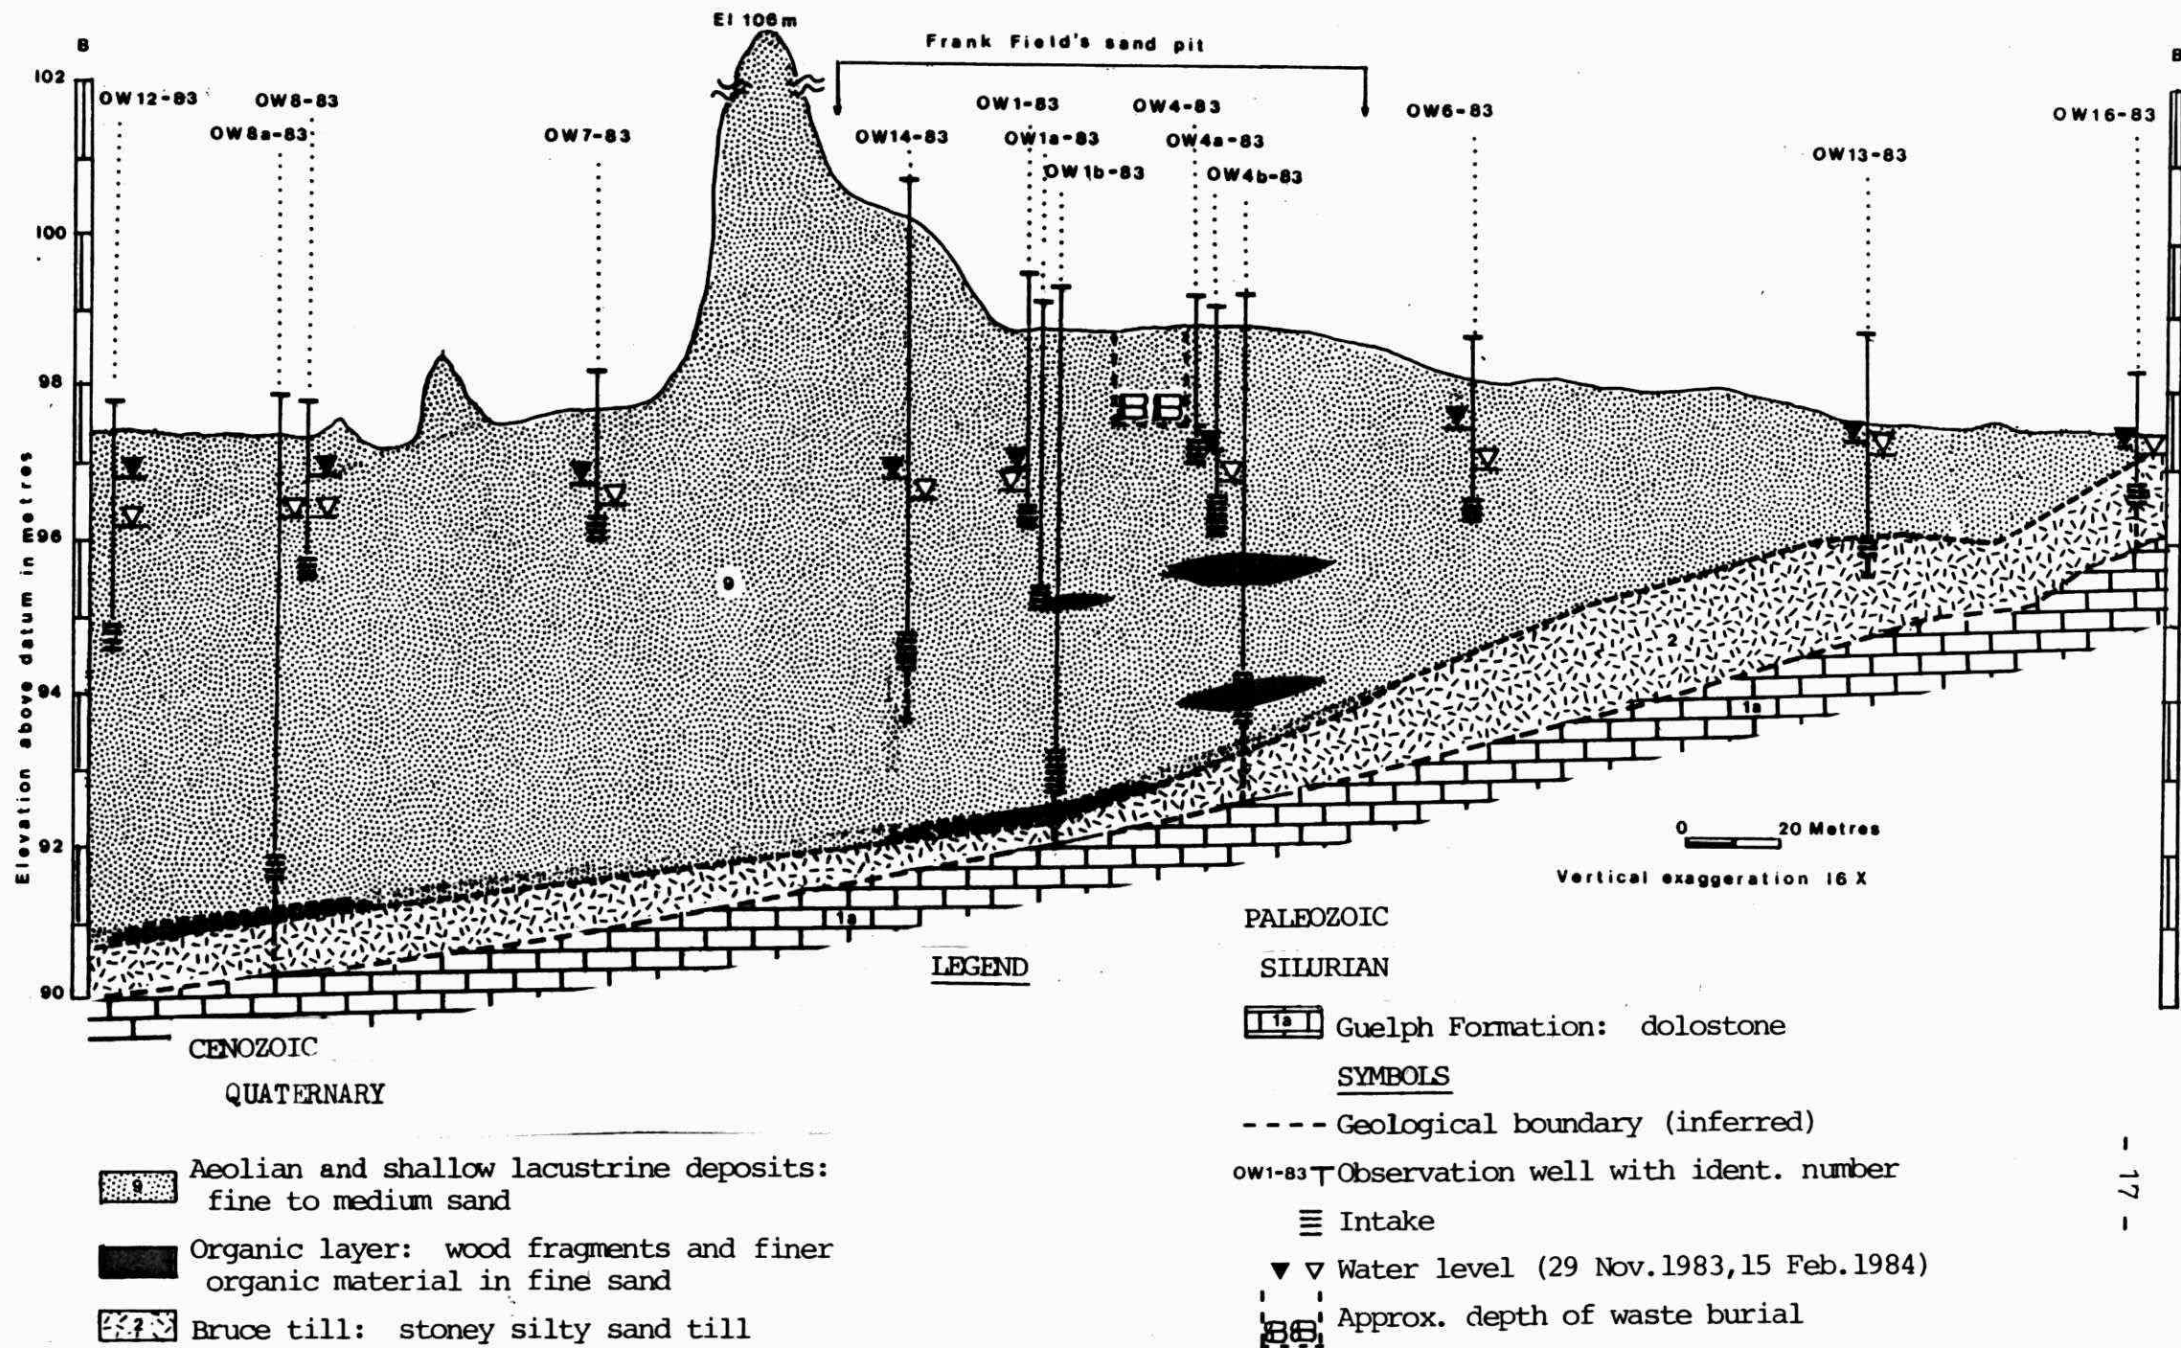
Figure 5. Cross-section B-B' illustrating local hydrogeology.

Glaciolacustrine and aeolian deposits mainly consisting of fine to medium grained sand form the surficial (water table) aquifer. The thickness of this granular material in the study area may reach 6 m and the depth to water level generally varies between 1 and 2.5 m. This largely depends on the topography and the time of the year when the water level measurement is made (Figure 5). As illustrated in Figure 6, there are significant water table

The hypsometric position of the buried drums is illustrated in Figures 4 and 5 respectively.

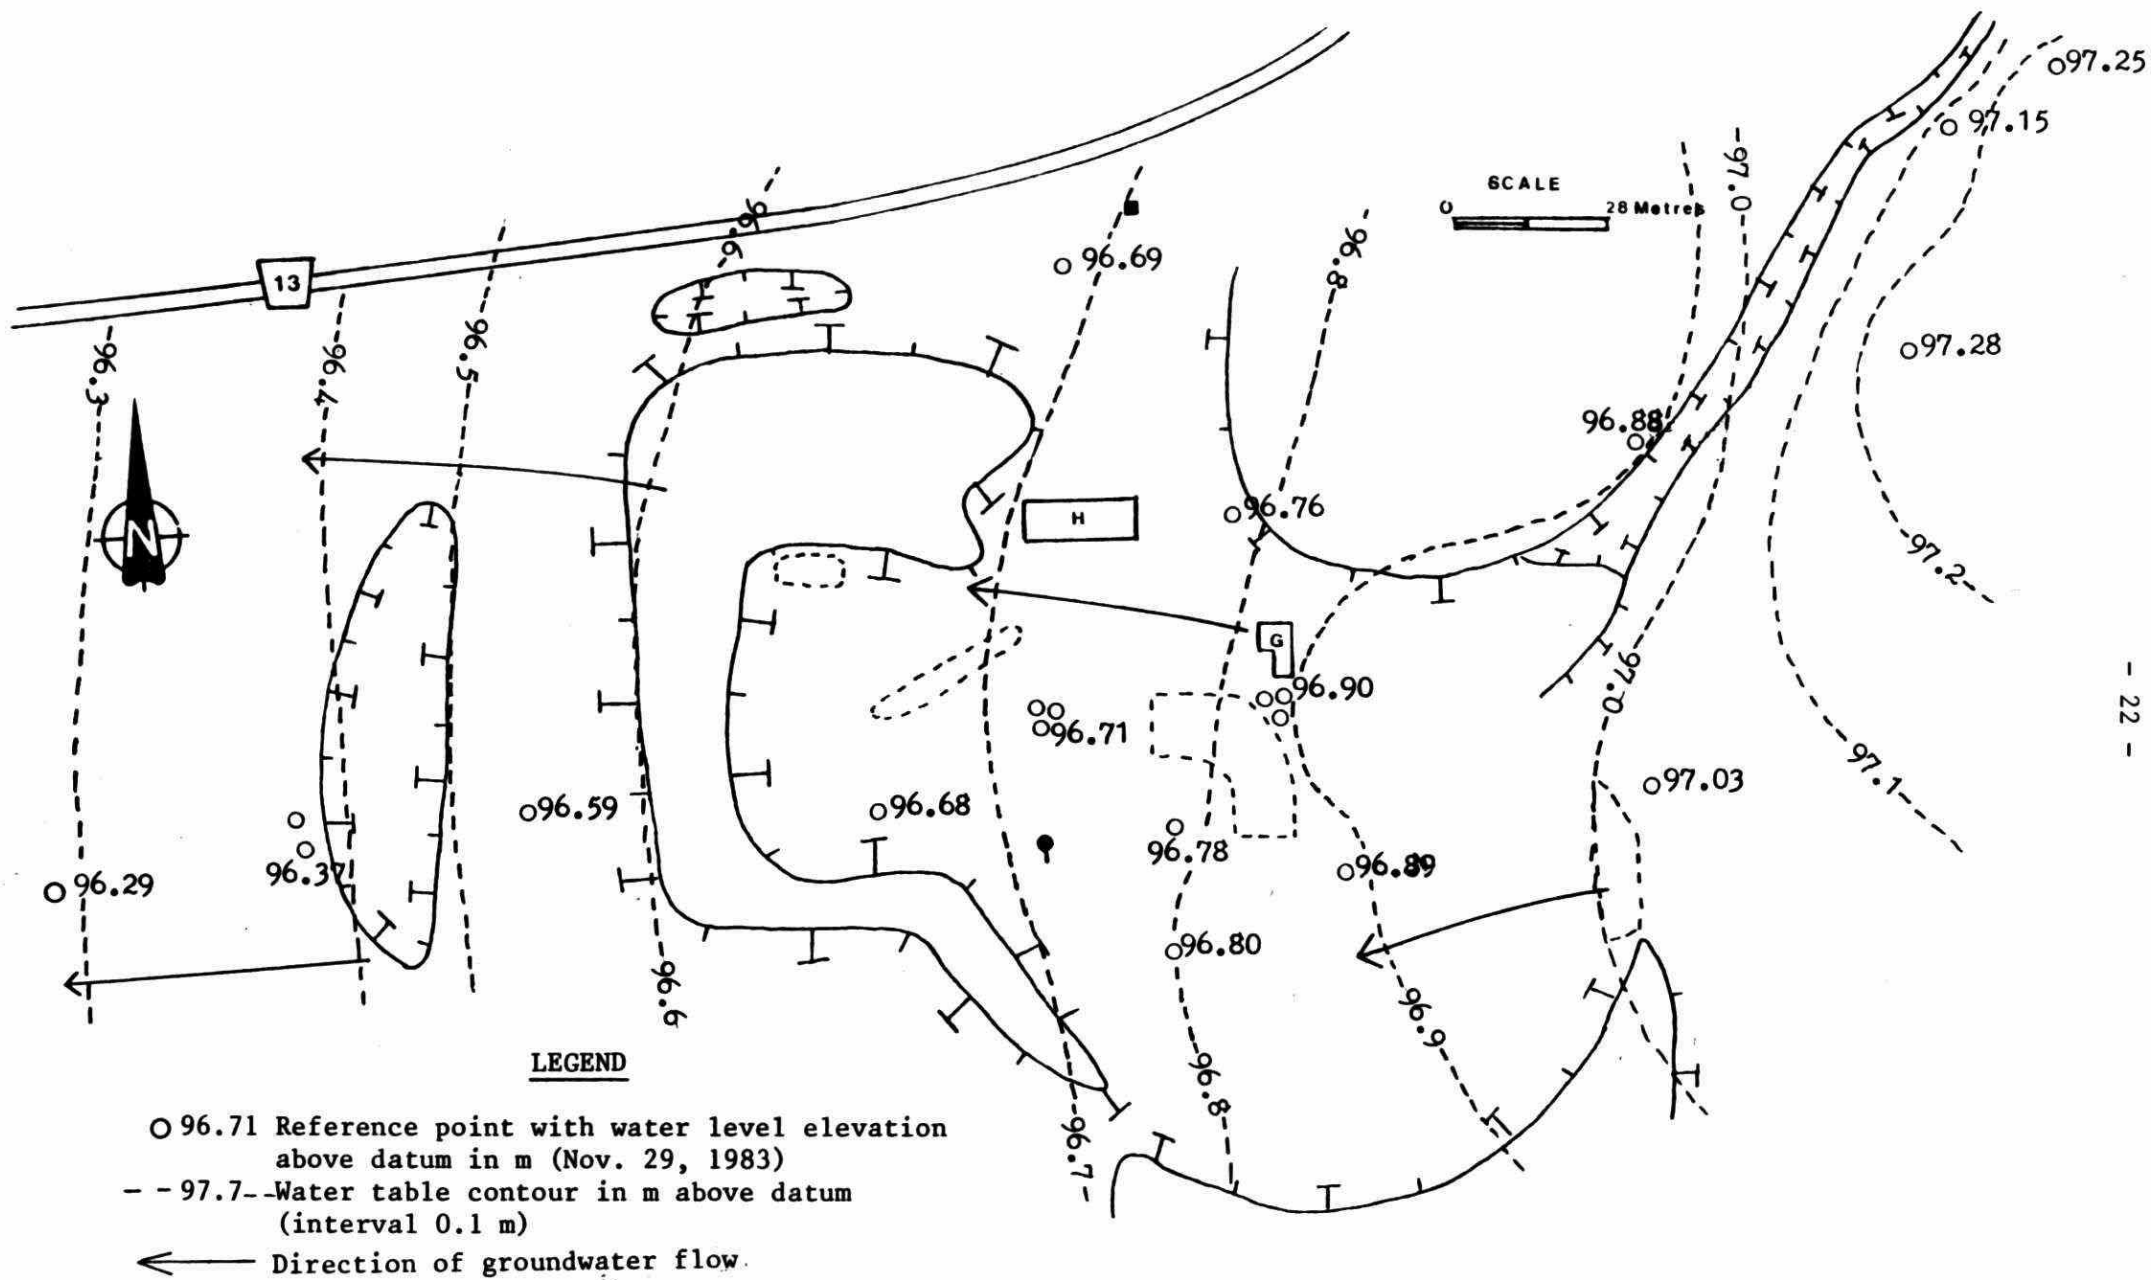
Figure 7. Water table configuration map.

Based on this information, there is a definite water table divide centered immediately east of the actual sand pit in question, but still on the Field property (Figure 7). This groundwater divide may shift from OW6-83 to OW13-83 depending on the season. Shallow groundwater flows, therefore is predominantly westward with some minor flow to the east.

Using the groundwater gradient for the November 29, 1983 measurement (Figure 7), it is calculated that the average groundwater velocity in the surficial sand is 36 m/a. This depends on the season which may to some degree influence the groundwater gradient.

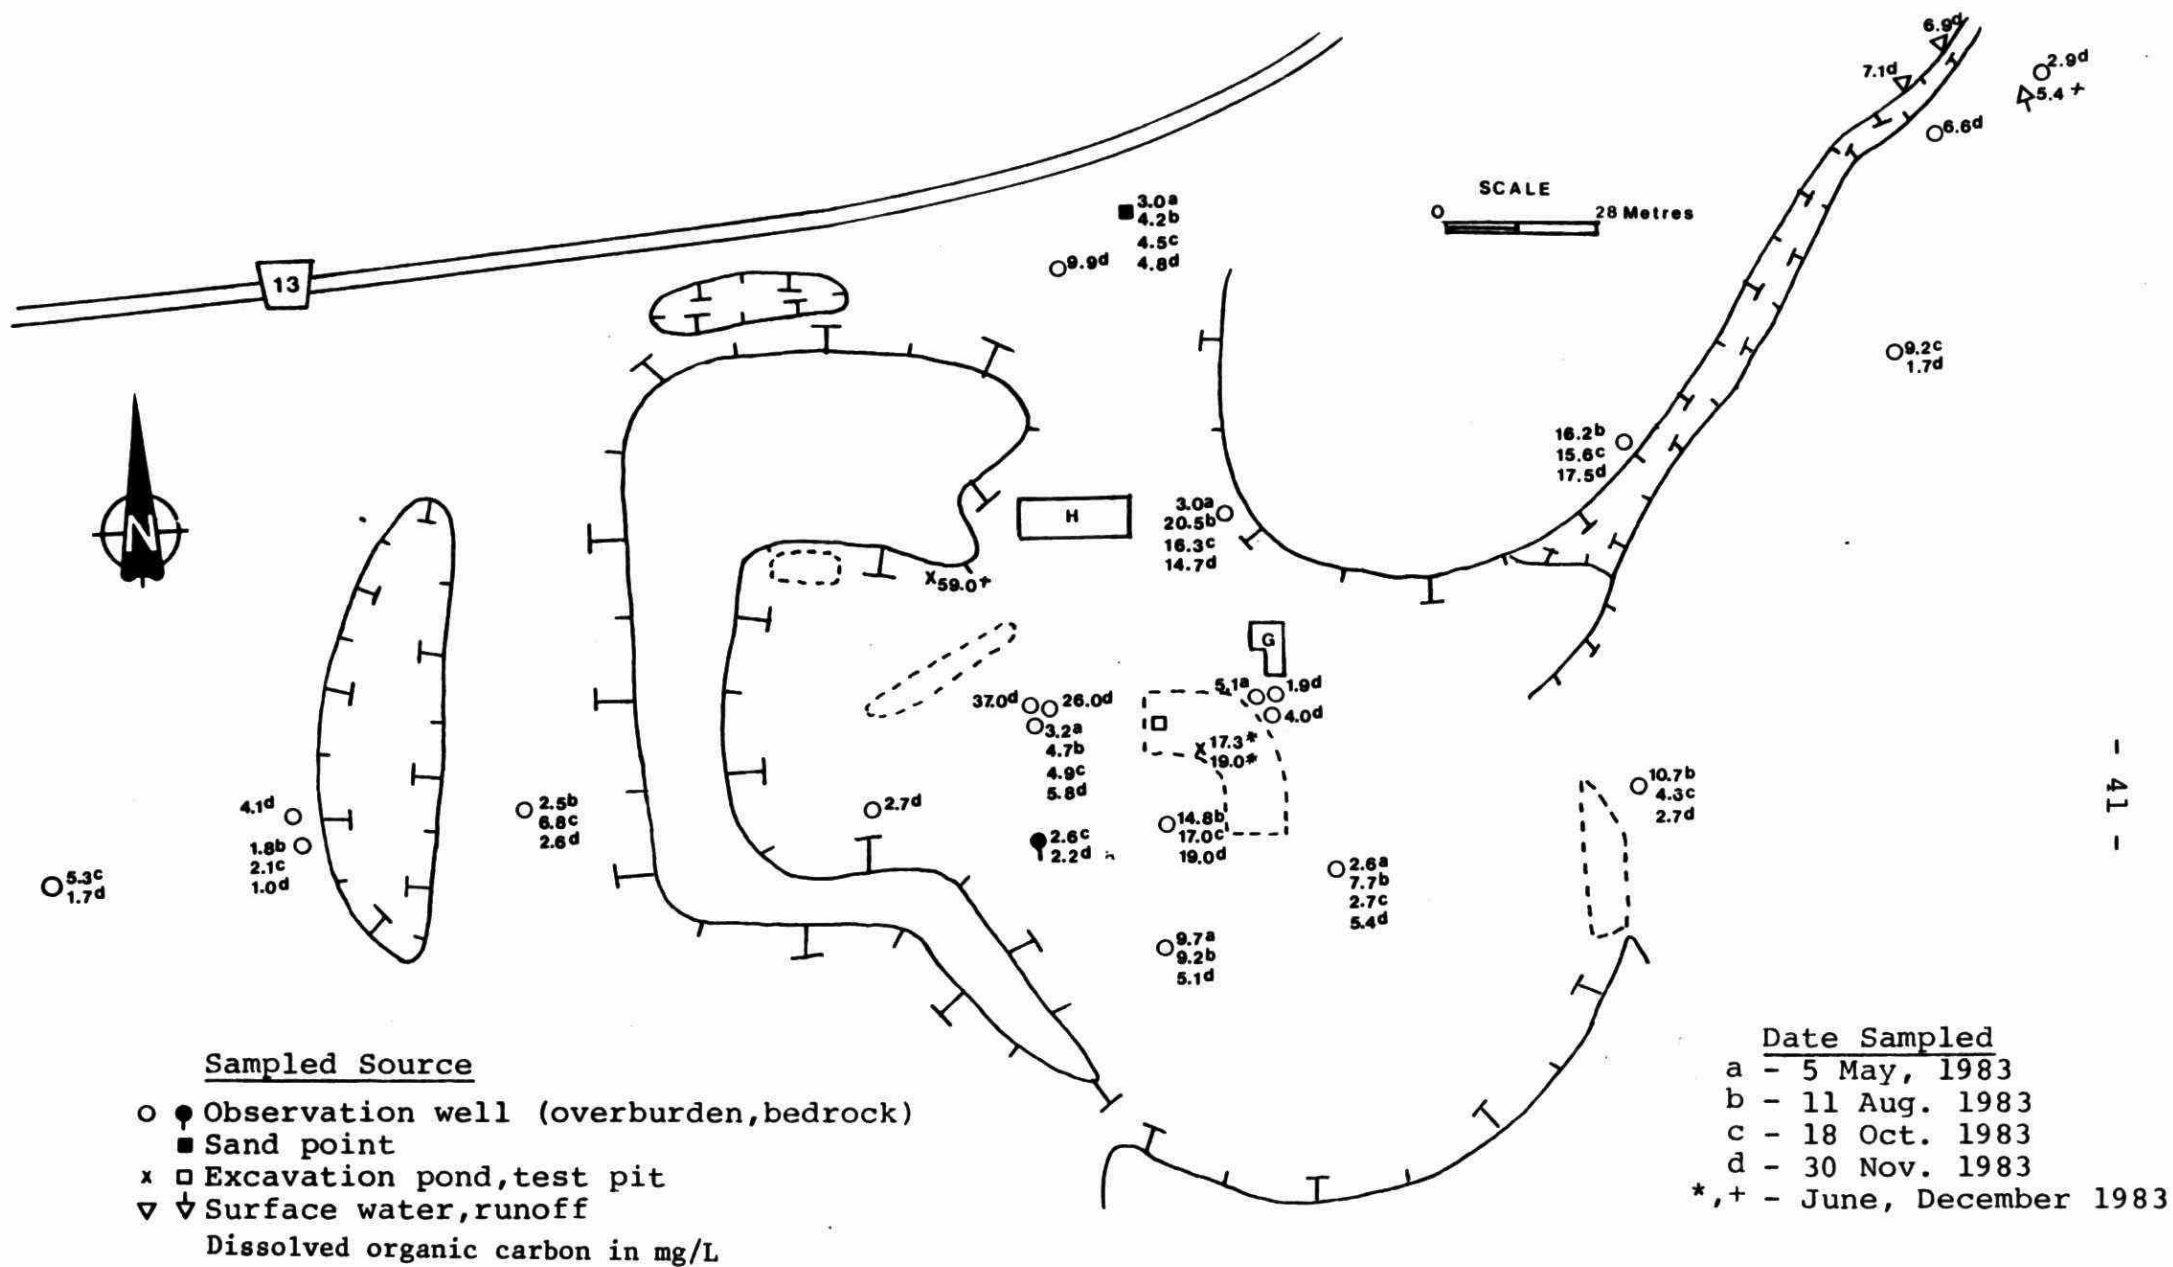
Figure 10. Hydrochemical map of dissolved organic carbon distribution in groundwater and surface water systems.

content of dissolved organic carbon, iron and phenolic compounds. This would be expected to occur in a similar geological environment.

7. Outside of the contamination plume, a few wells exhibited increased concentration of phenols or believed to be dissolved organic carbon on a few occasions. This is due to natural occurrences in combination with possible cross-contamination. For example, OW2-83 and OW10-83 have consistently shown elevated dissolved organic carbon which is due to the presence of organic deposits near the perforated portion of the piezometer (intake). Similarly, OW8-83, OW12-83 and OW13-83 reported elevated levels of phenols on the initial sampling date. Considering that these three monitoring wells were not developed after construction and before initial sampling, it is quite conceivable that phenols were the result of cross-contamination which may have occurred during their installation.

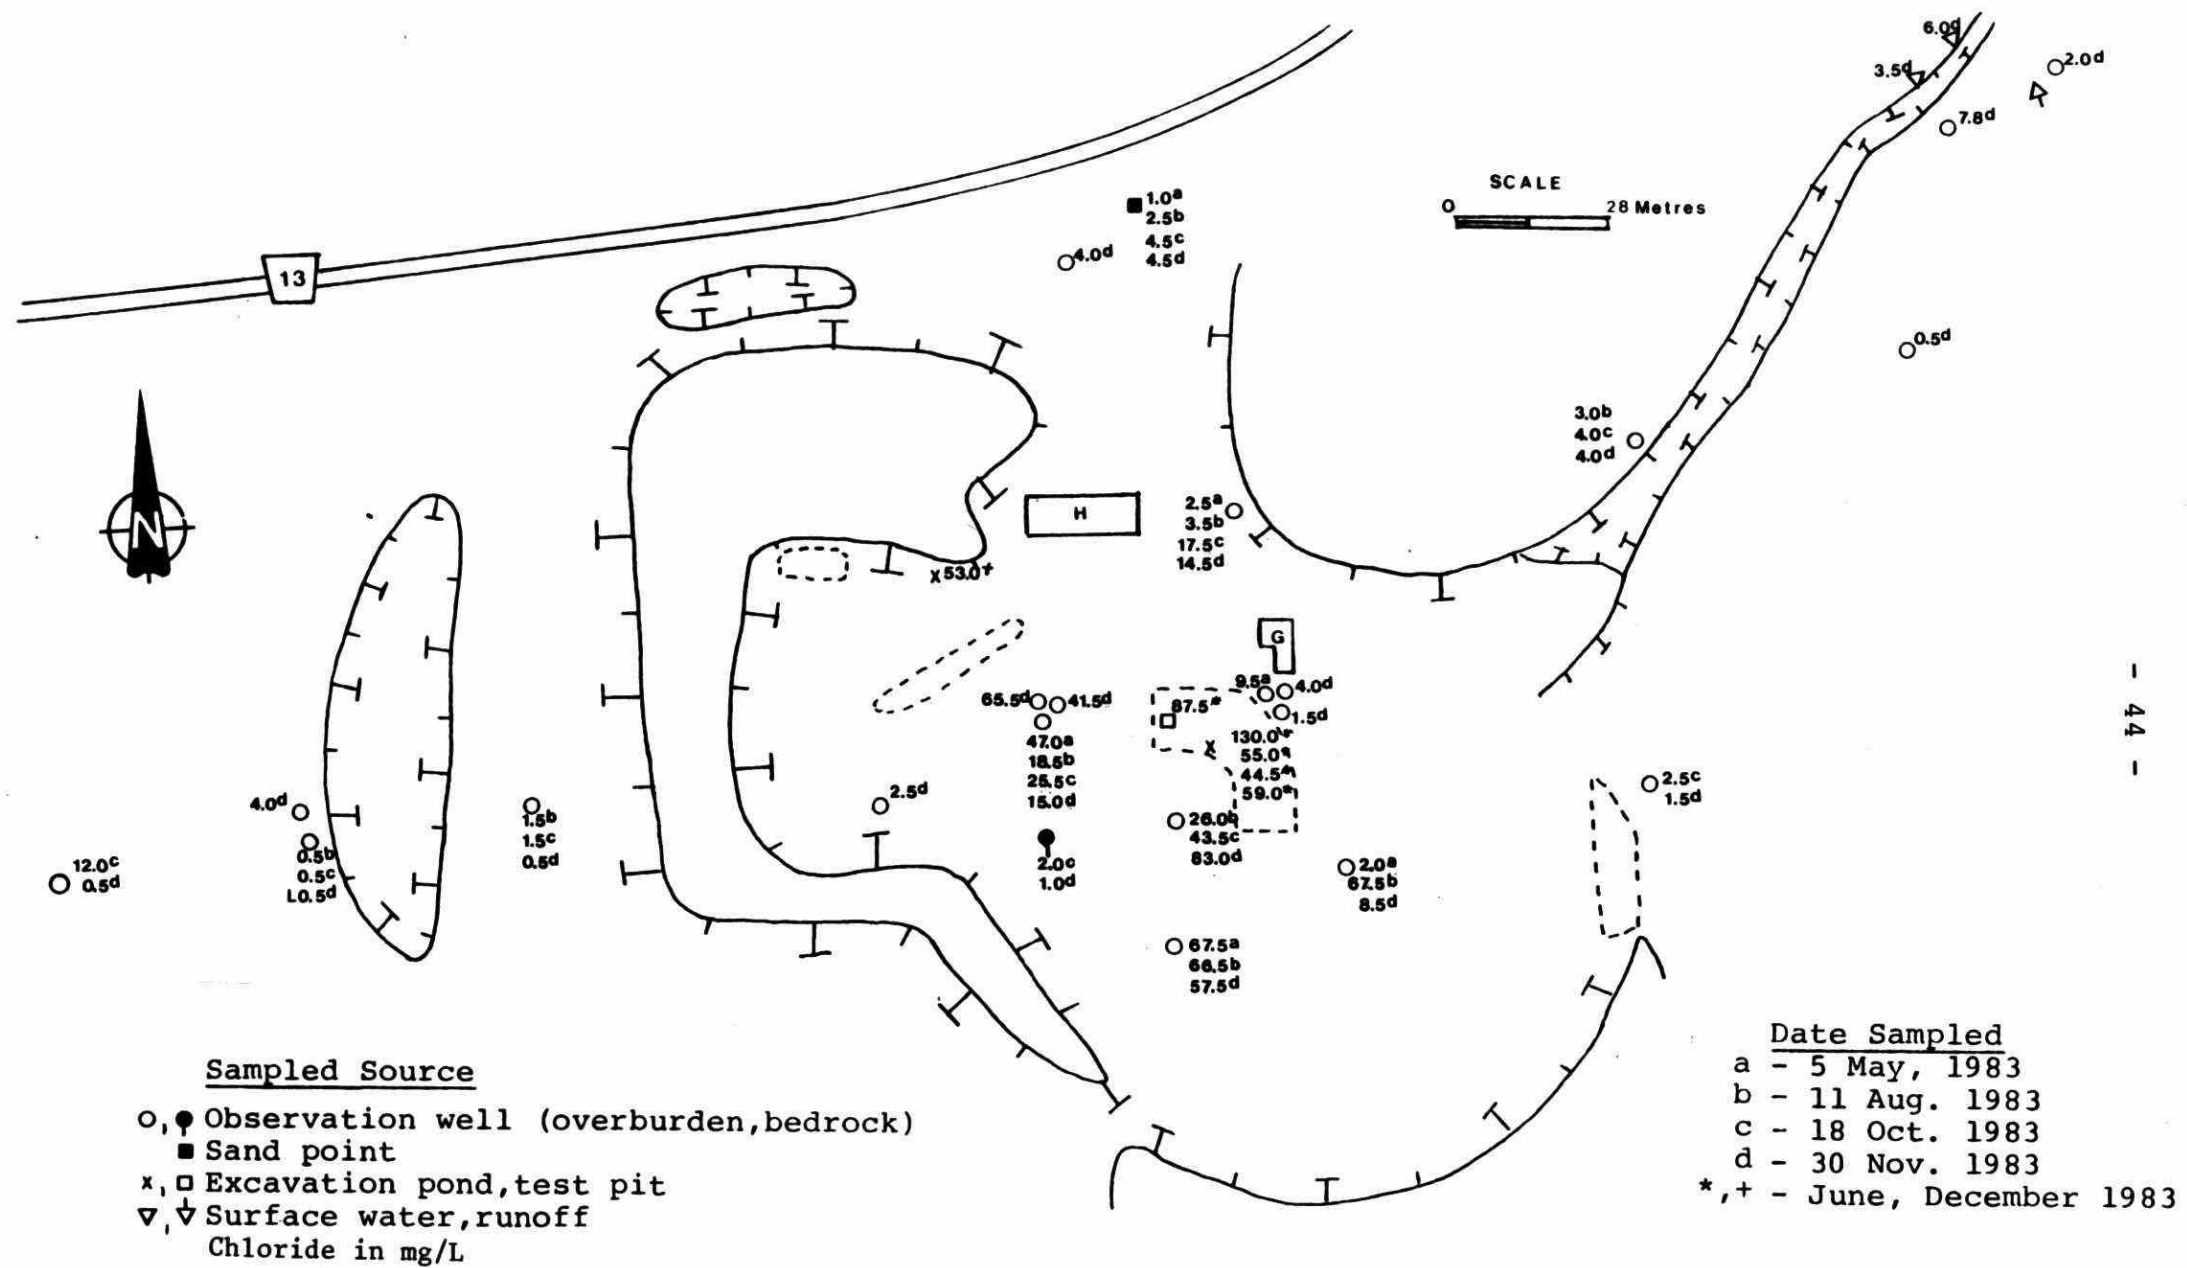
Figure 11. Hydrochemical map of chloride distribution in groundwater and surface water systems.

8. It is considered that the subsurface sand and water contaminated by buried industrial waste in clean-up area 4 is confined to a zone beneath and a short lateral distance from that area. There is no indication that plumes associated with two clean-up areas (1 and 4) are already connected.
9. Wastes in three other clean-up areas (Nos. 2, 3 and 5) had apparently not generated any significant contamination plume.

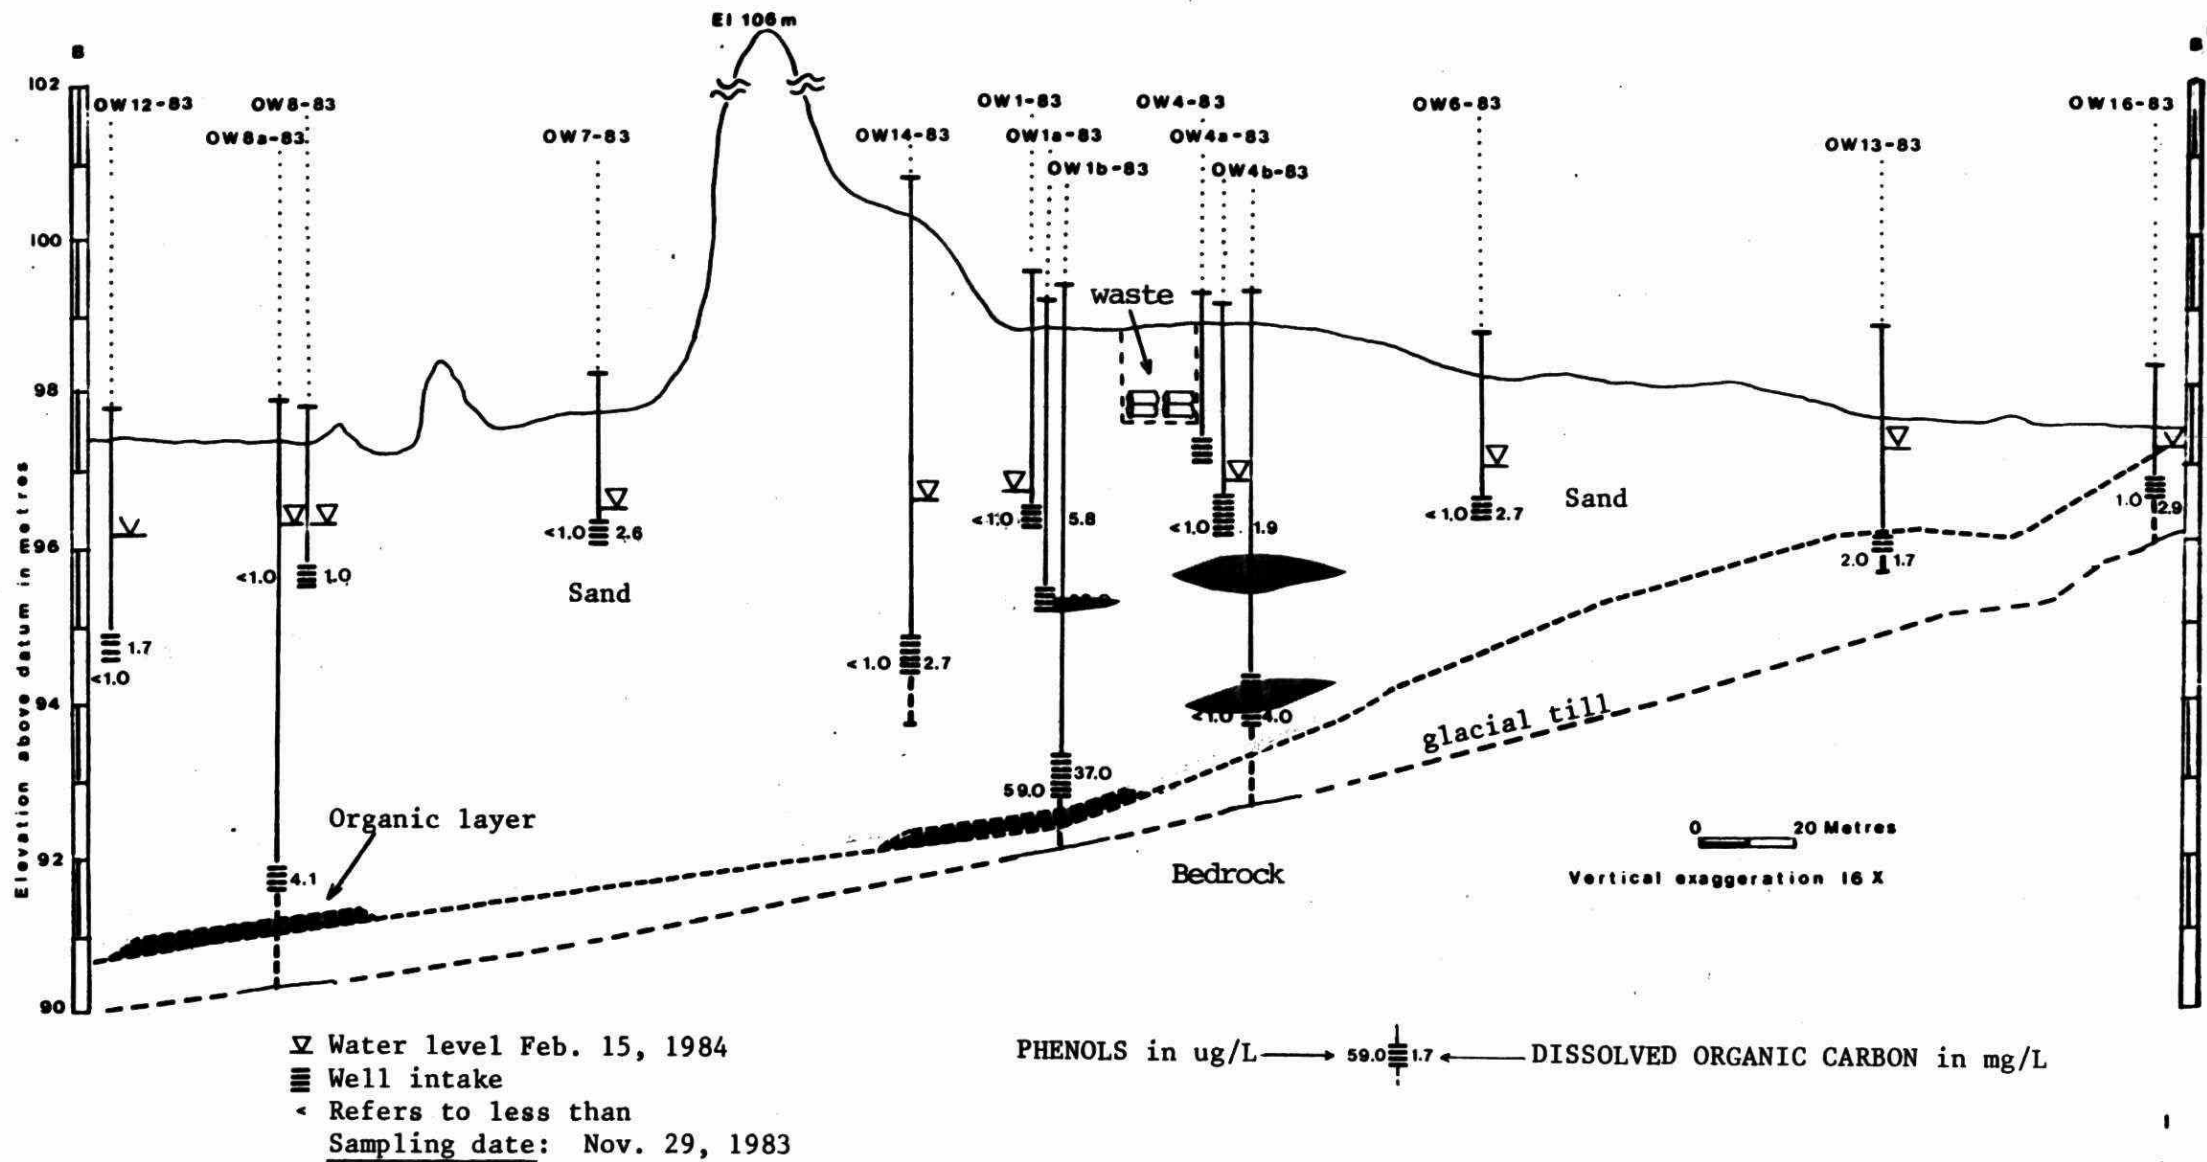
Figure 12. Concentrations of phenolic compounds and dissolved organic carbon along the cross-sectional plan B-B'

It is significant to note that the results of water quality analyses for OW1-83 (shallow well sampling the very top of the saturated zone) did not have any significant levels of phenolic compounds. Subsequent installation and sampling of two deeper observation wells at this location, a part of the same piezometer nest, showed relatively high levels of phenols and DOC. This suggests that the contamination plume was initially missed by sampling of the very top of the saturated zone, thus giving initially a somewhat unrealistic picture of the existing situation.
